MEMORANDUM

RE: Tree Conditions in MidAmerican Energy Company's Illinois Service Territory

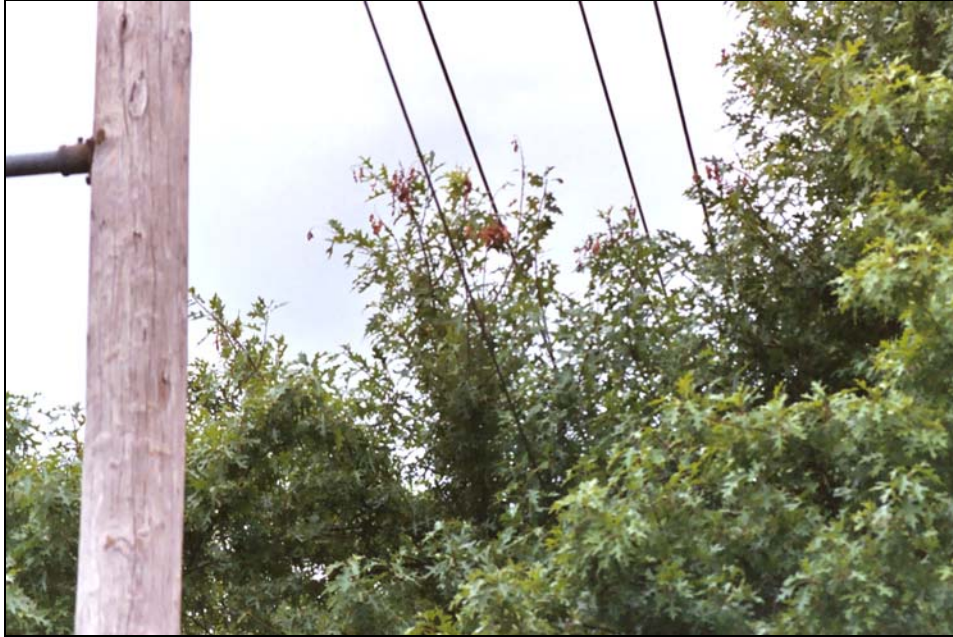
In Rock Island, Staff noted several tree conflicts at 1843 12th Street (Circuit 13-38-2) and along the alley west of 38th Street from 18th Avenue to 12th Avenue (Circuit 4-F-2). Figure 1 shows maple trees growing into the 3-phase 13.2 kV primary, with some burning of the trees, at 1843 12th Street. MEC indicated that tree trimming was last completed on this circuit in the fourth quarter of 2000, and is planned to be completed again in 2003.

Figure 1
Maple trees into 3-phase 13.2 kV primary, with burning
Circuit 13-38-2, Rock Island

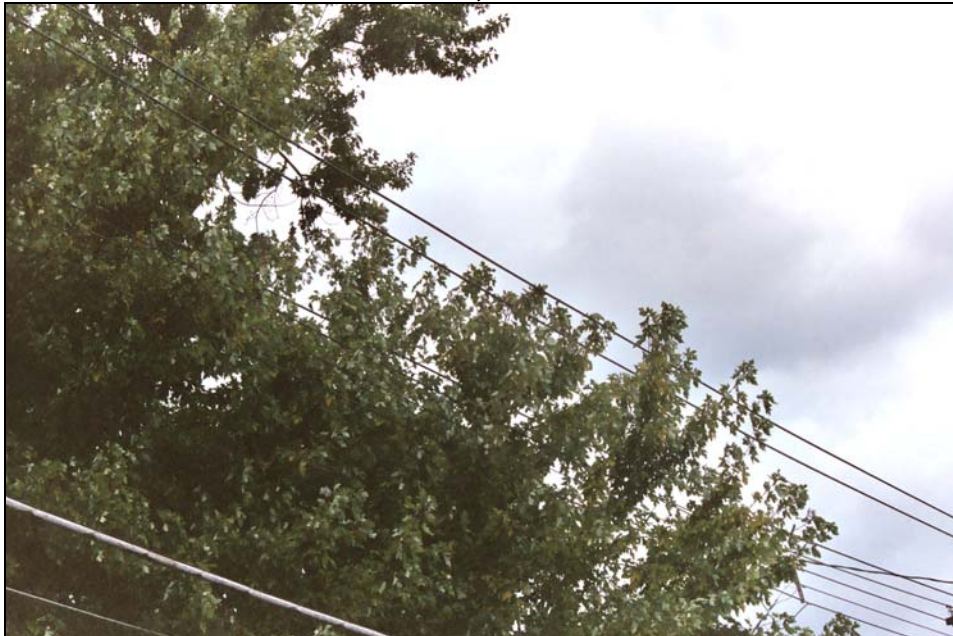
Figures 2 and 3 show MEC's 4 kV primary going through maple trees in the alley west of 38th Street, Rock Island. MEC claims that tree trimming was completed on this circuit on January 18, 2002, and is planned again for 2004.

Figure 2
3-phase 4 kV primary through maple tree
Circuit 4-F-2, Rock Island

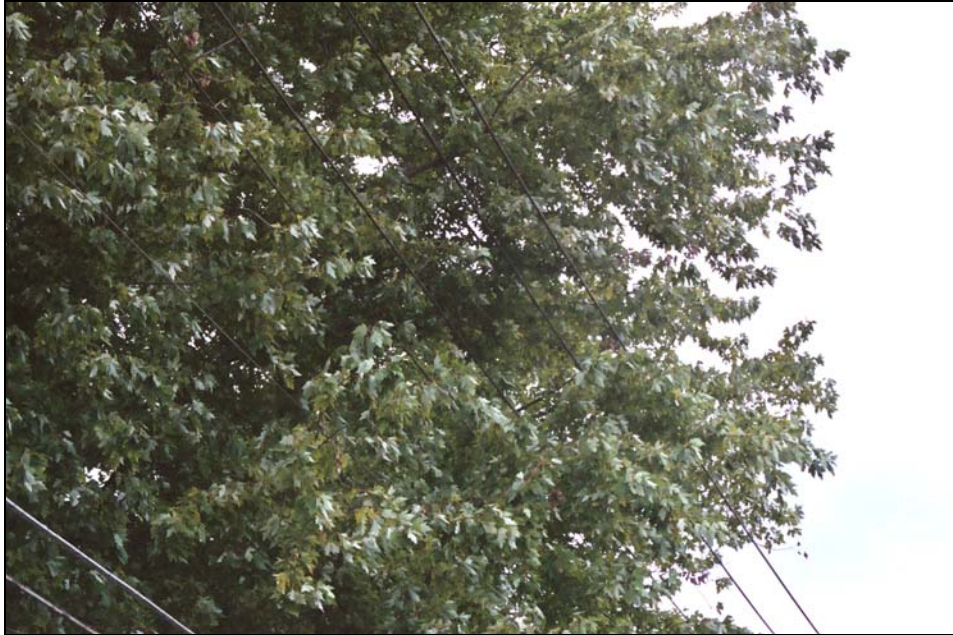
Figure 3
3-phase 4 kV primary through maple tree
Circuit 4-F-2, Rock Island

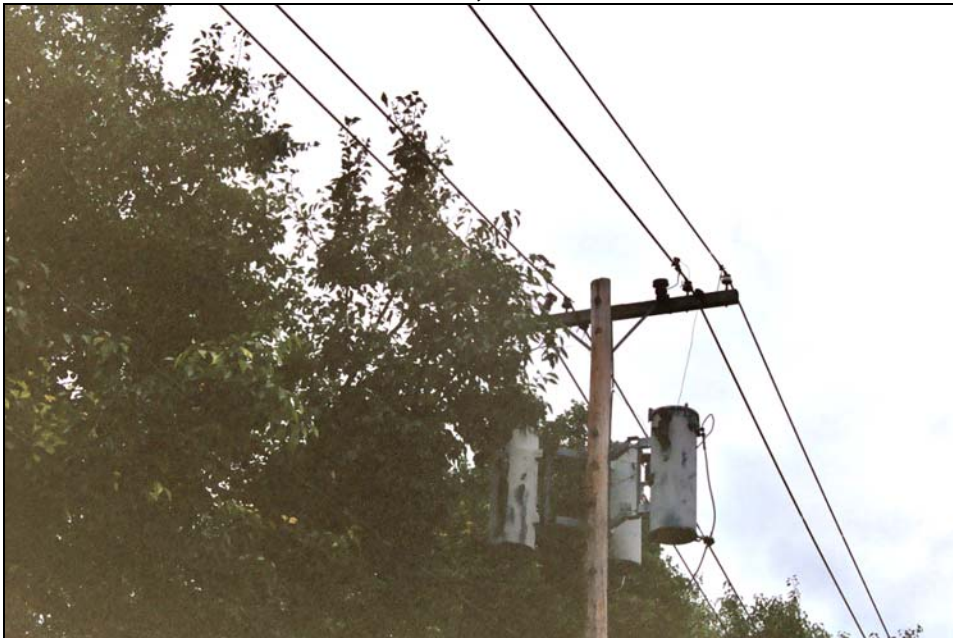
Figure 4 shows an ash tree growing into MEC's 4 kV primary at a 3-phase transformer bank in the alley west of 38th Street, Rock Island. Tree trimming was completed on this circuit on January 18, 2002, and is planned again for 2004.

Figure 4
Ash tree growing into 4 kV primary at a transformer bank
Circuit 4-F-2, Rock Island

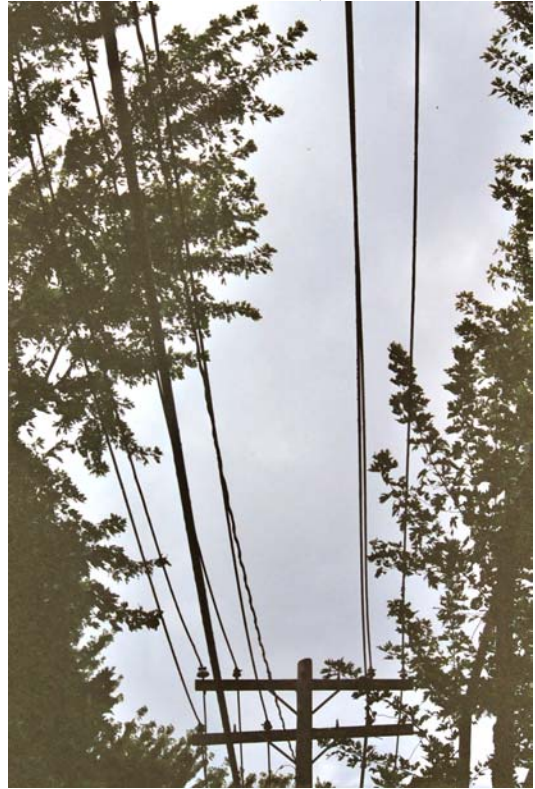
Figure 5
Primary burning maple tree
Circuit 13-PU-1, Moline

In Moline, Staff noted only two areas of tree conflict with MEC's overhead lines. Figure 5 shows one of these conflicts, across from 1407 18th Avenue. At this location, an MEC double-circuit primary goes through a maple tree, with some evidence of burning. MEC reported that its 13.2 kV Circuit 13-PU-1 at this location was last trimmed on January 16, 2002, and will be trimmed again in 2004.

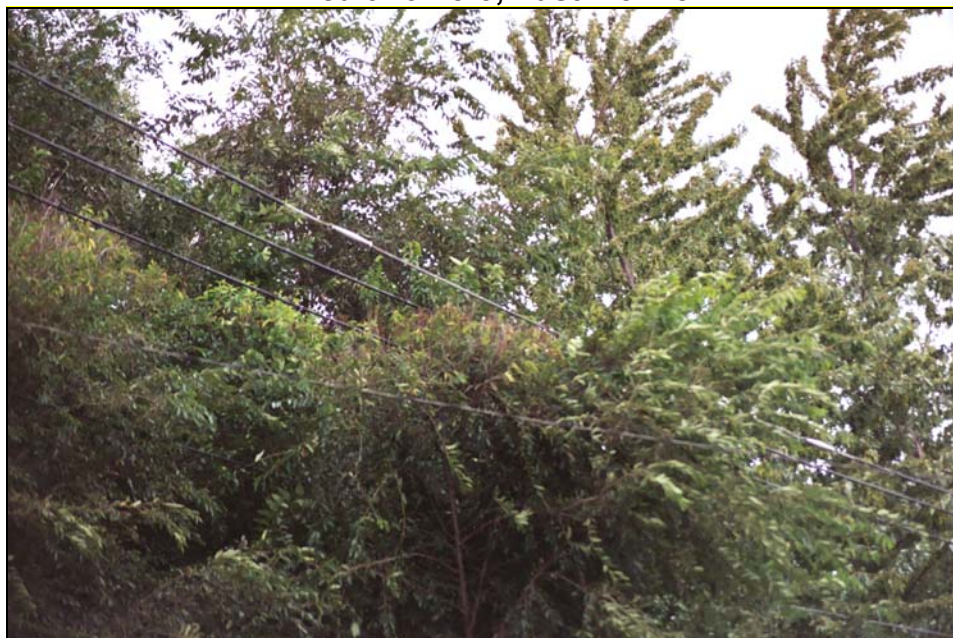
Staff found tree conflicts at three locations in East Moline, one of which involved a de-energized section of 3-phase primary going through and completely surrounded by trees north of 2617 19th Street. Figure 6 shows 3-phase 13.2 kV Circuit 13-48-3 (or 13-48-4) burning the top of an elm tree on 19th Street north of Route 92. Tree trimming was reported to be currently in progress on this circuit, scheduled for completion by the end of 2002.

Figure 6
13.2 kV primary burning the top of an elm tree
Circuit 13-48-3, East Moline

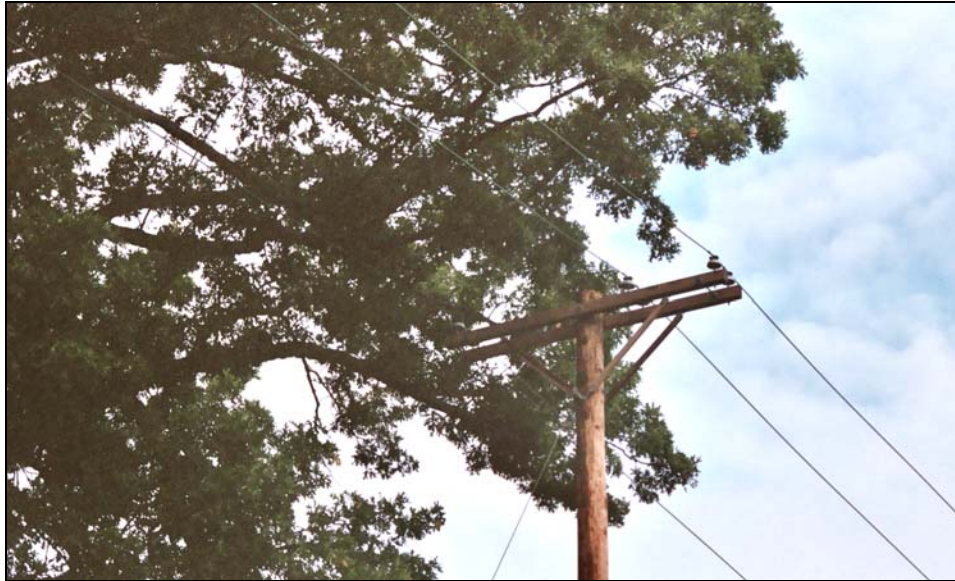
Figure 7 shows an oak tree growing above and very close to 3-phase 13.2 kV Circuit 13-E-3 at 2015 13th Street, East Moline. MEC reported that tree trimming was last completed on this circuit on February 14, 2002, and is planned again for 2005.

Figure 7
**Oak tree above and very close to 13.2 kV primary
Circuit 13-E-3, East Moline**

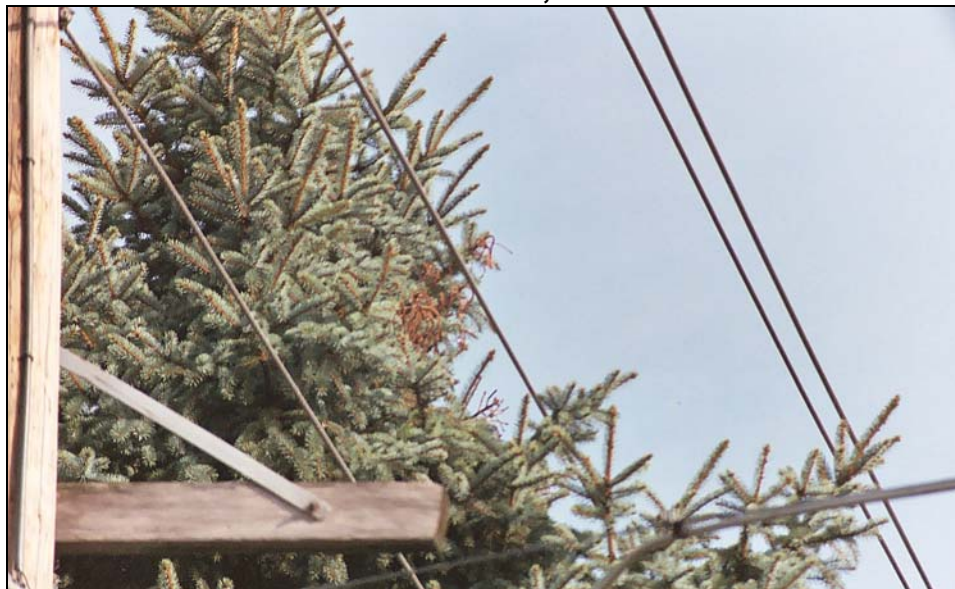
Staff observed tree conflicts at several locations in Silvis. Figure 8 shows 3-phase 13.2 kV Circuit 13-48-3 burning a spruce tree on 10th Street at 10th Avenue. Tree trimming is currently in progress on this circuit, scheduled for completion by the end of 2002.

Figure 8
**13.2 kV primary burning spruce tree
Circuit 13-48-3, Silvis**

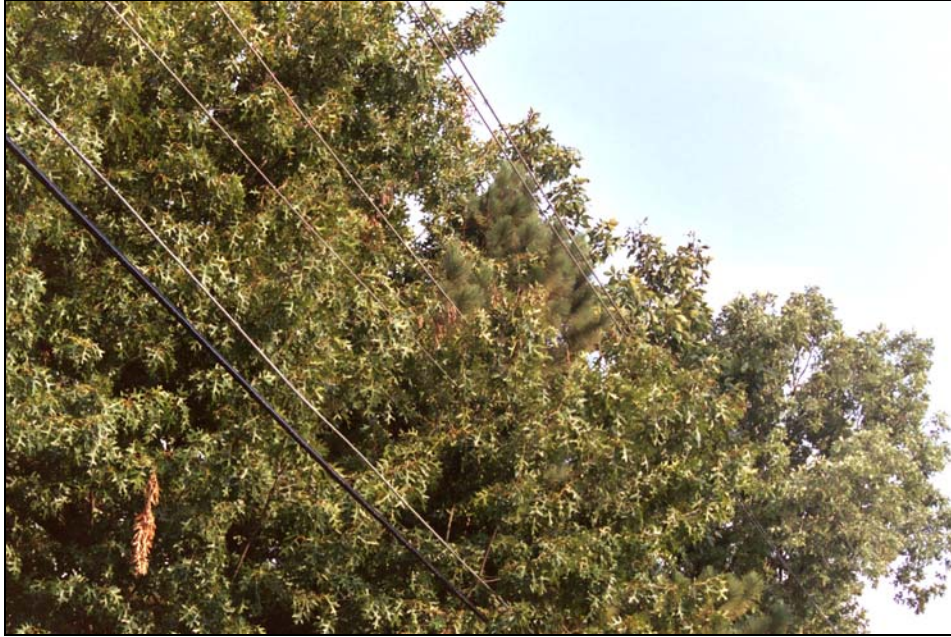
Figures 9 and 10 show 3-phase 13.2 kV Circuit 13-48-2 in oak trees, with burning, at two locations in the alley between 15th & 16th Streets, near 4th Avenue, Silvis. Trees on this circuit are currently being trimmed, scheduled for completion by the end of 2002.

Figure 9
13.2 kV primary in pin oak tree, with burning
Circuit 13-48-2, Silvis

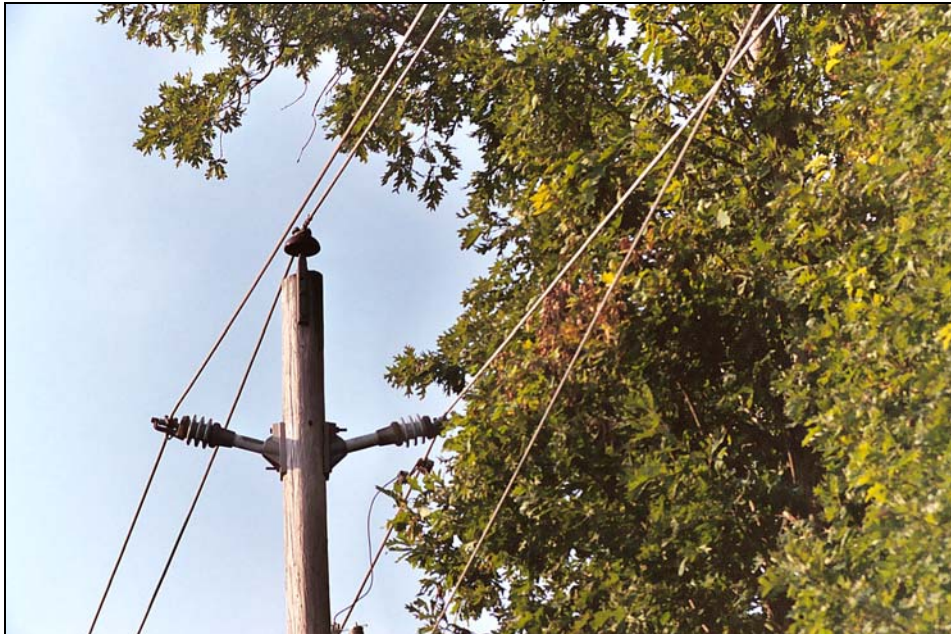
Figure 10
13.2 kV primary burning oak tree
Circuit 13-48-2, Silvis
